Sunbeam Food Processor Triac Replacement

A common fault in motorized kitchen appliances is failure of the speed control Triac and/or associated Diac. This teardown shows you how to get to and replace the Triac and Diac in a Sunbeam food processor.

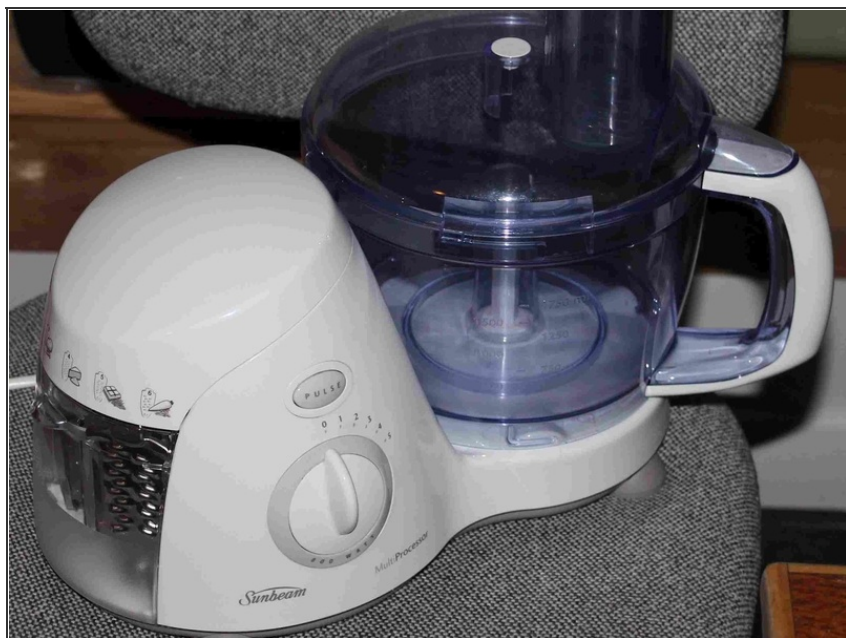
Step 1 — Sunbeam Food Processor Triac Replacement

- The Sunbeam food processor.
When plugged into the wall it starts at full speed, and the speed control dial can't turn it off or adjust the speed.
- This is a common mode of failure when a speed control Triac has gone short circuit, or failed partially, becoming easily triggered. This usually happens after a voltage spike from an inductive load, like the motor in the appliance, or something else plugged in nearby.
- Do not under any circumstances dismantle the unit with power applied, as it is double insulated and you could be electrocuted and a residual current earth leakage device will probably not be able to trip to save you.
- If you are not confident with mains wiring, get someone who is to do this repair for you.

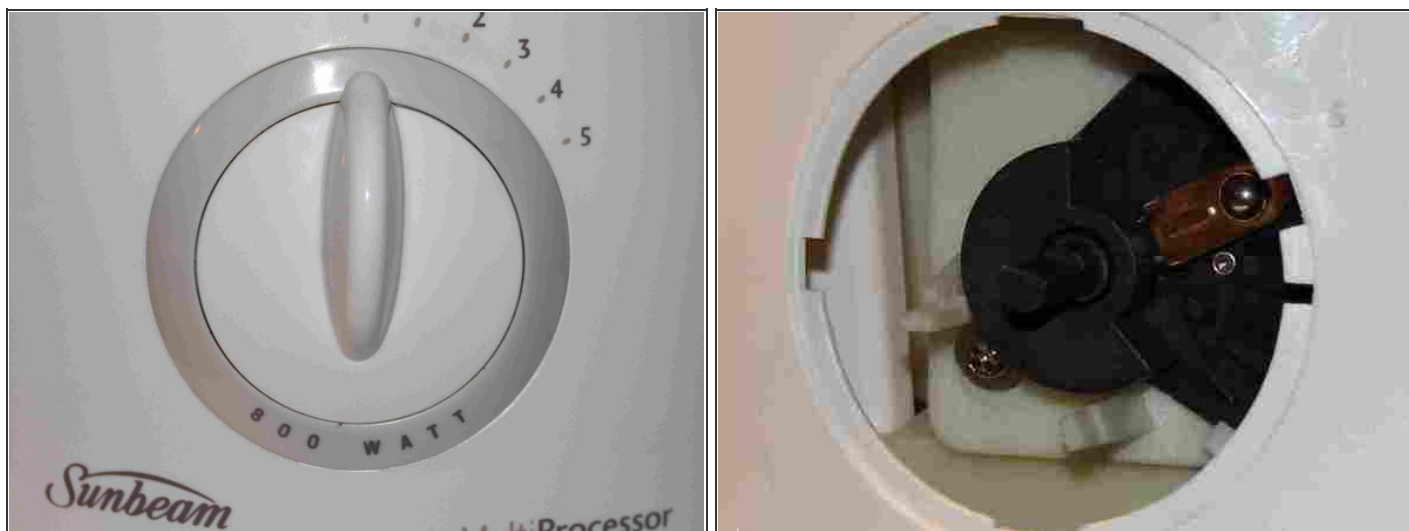
Step 4

- Next, the speed control dial must be carefully popped out.
- This exposes the rotary switch underneath.

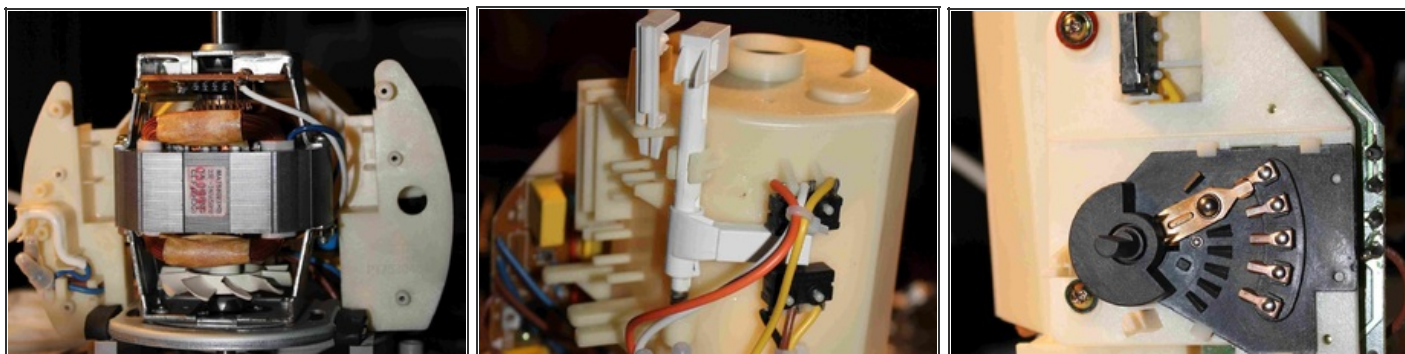
Step 7

- The motor housing can be inspected, and the first photo shows the armature and carbon brushes of the motor.
- The second photo shows the safety interlock switches, which are actuated via the toggle you removed earlier, when the mixing bowl is locked into place.
- The remaining third side of the motor housing has the switchboard/PCB subassembly attached, with the "pulse" microswitch and rotatory on/off and speed control switch exposed
